# FABRICATION AND TESTING OF LIGHTWEIGHT HYDRAULIC SYSTEM SIMULATOR HARDWARE—PHASE II

**Rockwell  
International**

Addendum Report for Period, 2 January 1986–15 July 1988

**NAVAL AIR DEVELOPMENT CENTER**  
**Aircraft and Crew Systems Technology Directorate**  
**Warminster, PA 18974**

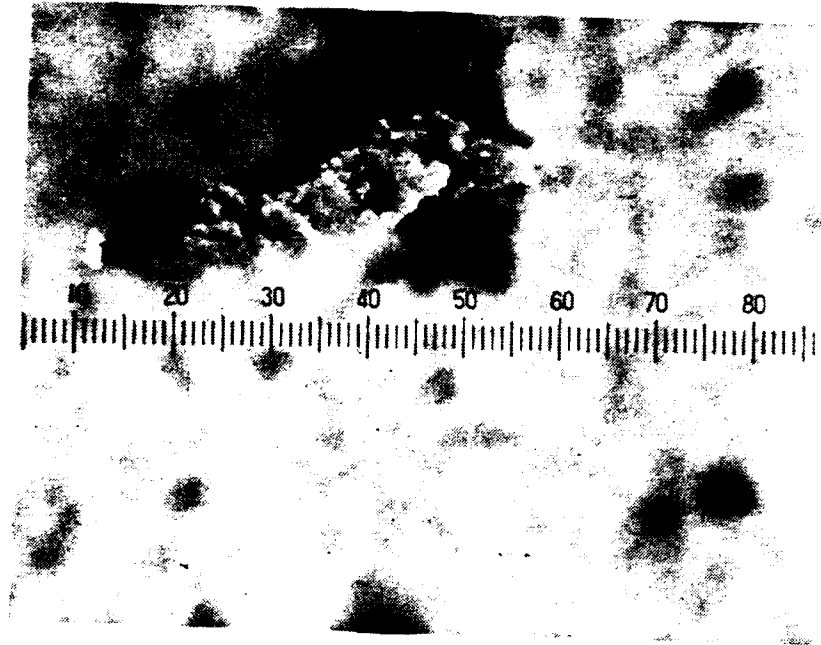
Particle Type IV

The light yellow/green particle depicted in this photomicrograph is representative of Type IV particles filtered by APN (5 micron absolute) filters in pressure-line, return-line and case-drain locations. The elemental composition of this type of particle included major silicon, minor magnesium and titanium and traces of chlorine, copper and iron. The Magnification is 200X. The reticle measures 0.2 microns per division.

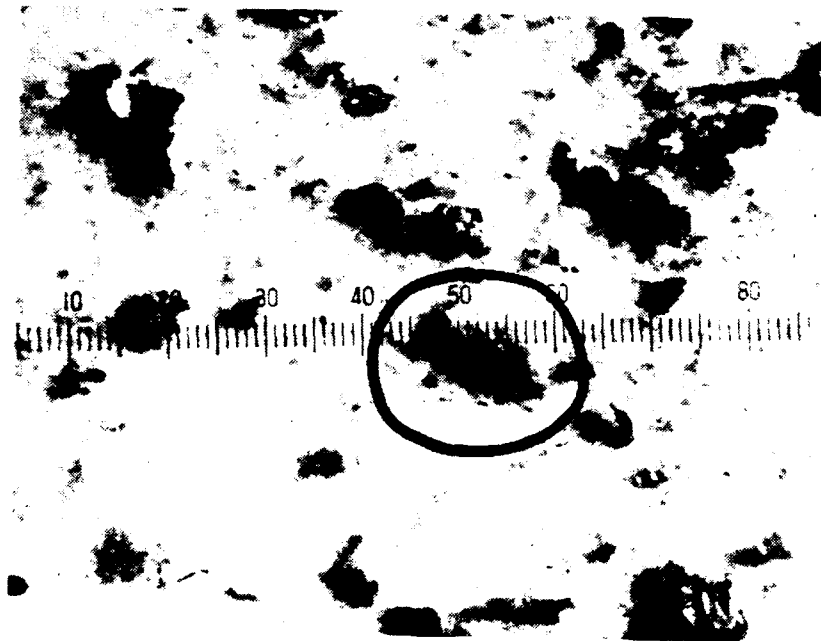
Particle Type VII

The particle circled in this photomicrograph is representative of Type VII particles filtered by APM (5 micron absolute) filters in pressure-line, return-line and case-drain locations.

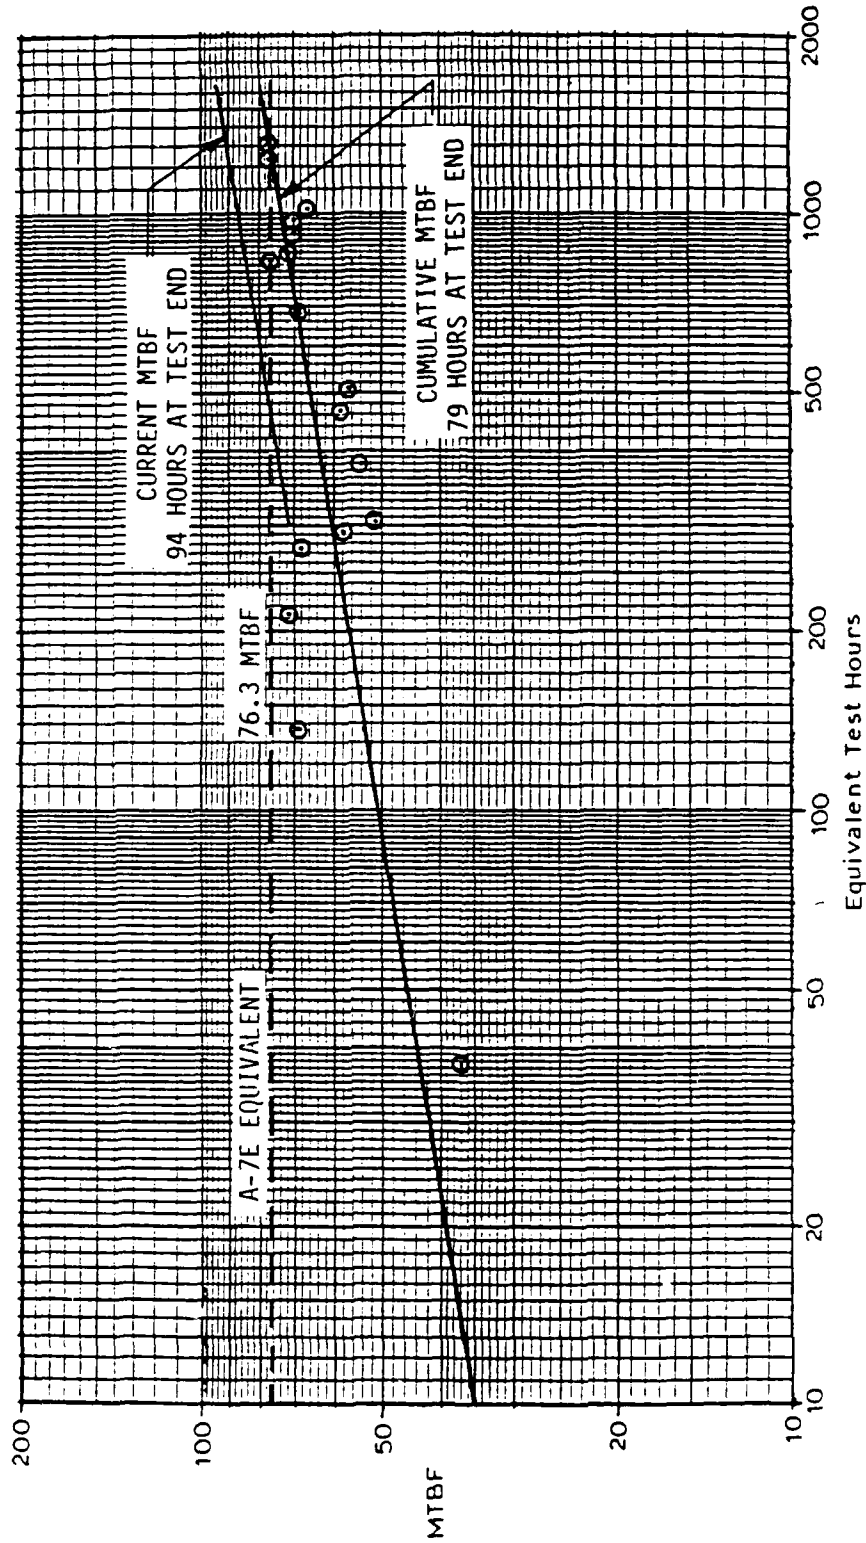
Figure 1. LHS Reliability Growth - 0 to 600 Hours of Simulator Operation

- I. Identify and Collect Available Data - The data for this effort was derived from the 600 to 1200-hour portion of LHS simulator endurance operation performed under the Phase II effort. This data will be included in an addendum to the Phase II final report.
- II. Perform Analysis of Failures - Each failure was analyzed, the cause and effect determined, and a corrective action was recommended. Corrective actions were not initiated in all cases depending on the effect of the failure on simulator operation and the availability of resources. This data is included in an addendum to the Phase II final report.
- III. Statistical Summary and Reliability Trend Analysis - A reliability growth trend line had been generated for the first 600 hours of simulator operation and is shown on Figure 1. This is based upon

the failures that occurred during the first 600 hours of simulator operation. The data for that period is detailed in the Phase II final report number, NADC-79024-60, discussed above. A revised and updated reliability growth trend analysis was generated for this task by incorporating the data obtained from the 600 to 1200 hour LHS simulator operation.

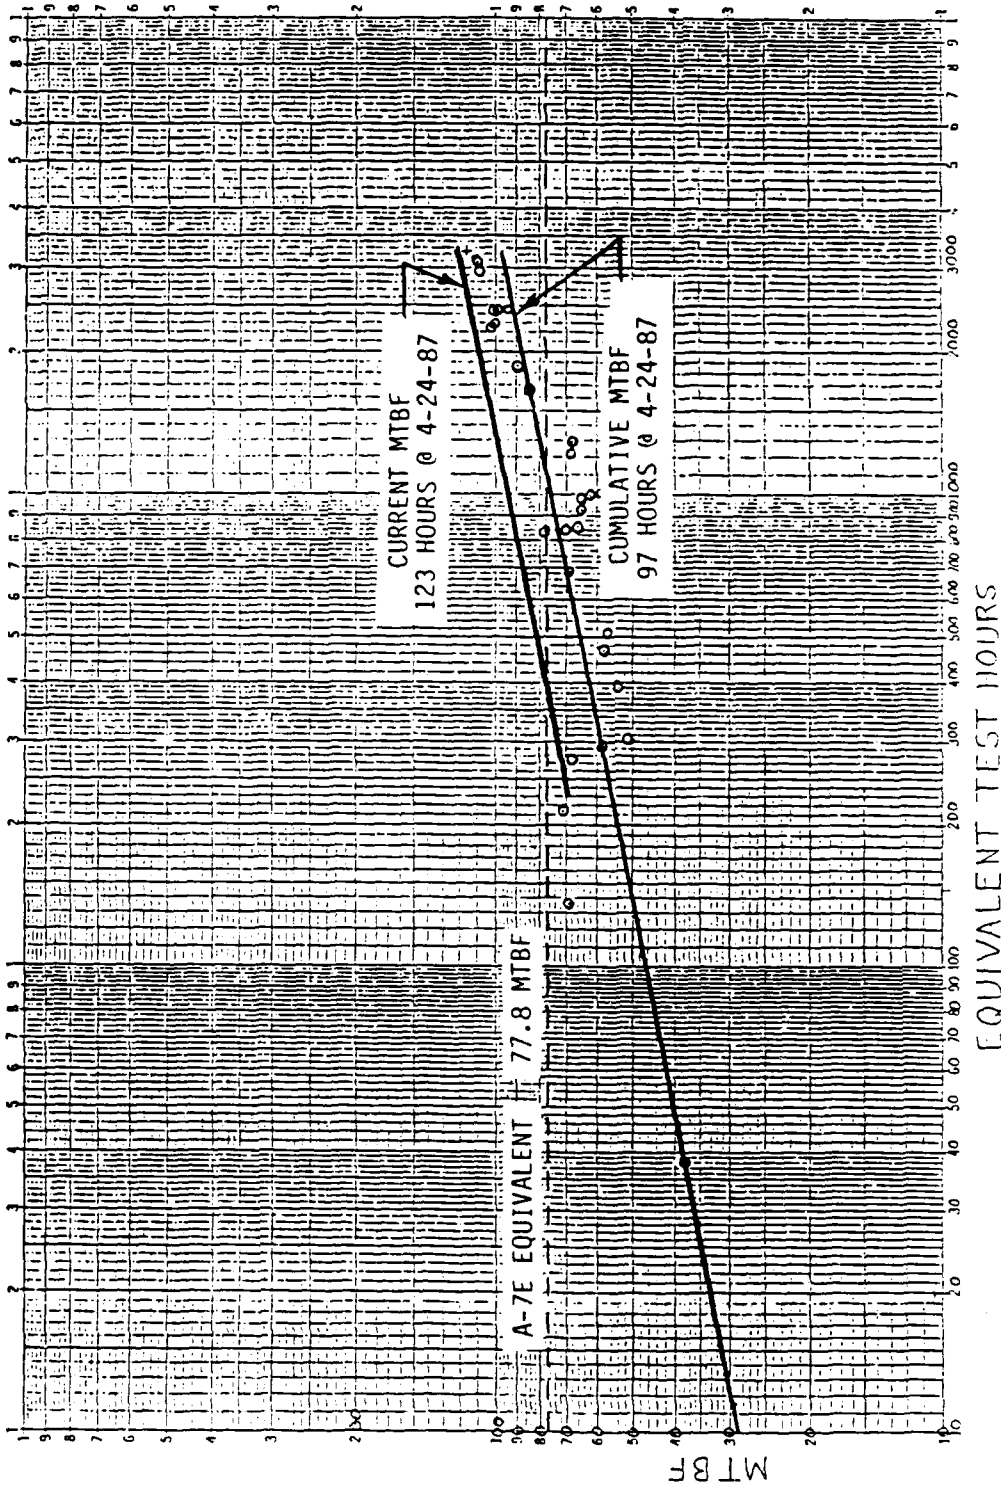
Figure 2. LHS Reliability Growth - 0 to 1200 Hours  
of Simulator Operation

(2) Summary excludes coil tube failures, pump rework and non-hydraulic related mechanical failures.
